RESULTS OF BORON-ALUMINUM THRUST STRUCTURE TEST

Interim Report

This report presents the results of testing-to-failure a two member boron-aluminum thrust structure. The structure represented one section of a more complex planar truss and was designed to test the integrity of a diffusion bonded joint. The structure failed at 107 percent of the ultimate design load in the diffusion bond region. Strain gages and displacement transducers were used to measure loads and deflections of the truss. The experimentally derived axial loads, bending moments and torsion in the various members are presented and compared with predicted values. In general, the comparison is quite good.

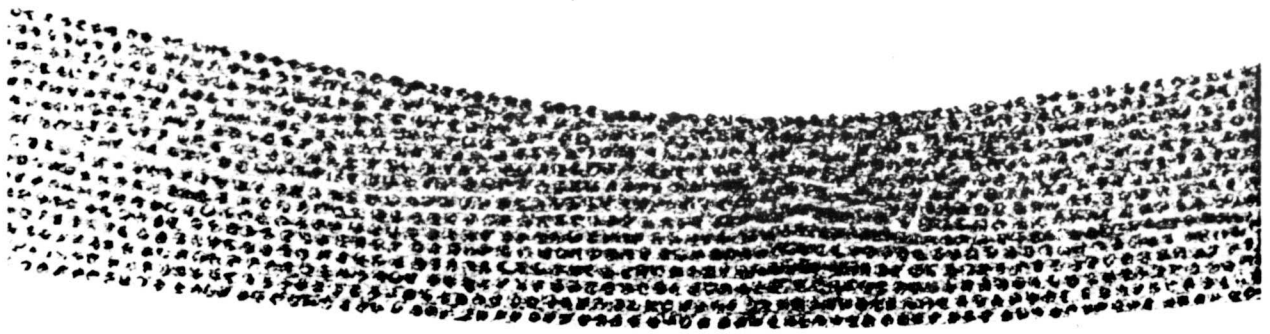
Figure A-1. Enlargement of compression tube wall sections.

Careful examination of a small tube section revealed a thin ply region, which covered a very short distance of arc length, running the entire length of the tube. This seam was generated during fabrication of the tube. Figure A-1 shows an enlargement of both a normal cross-sectional segment of arc length and this thinner region. The thin region covered an arc length of 3.175 mm compared to the total circumferential distance of 355.6 mm and was not considered in the calculation of area used to determine E from the compression tests.
